Railmaster and Hornby Elite in Windows 10

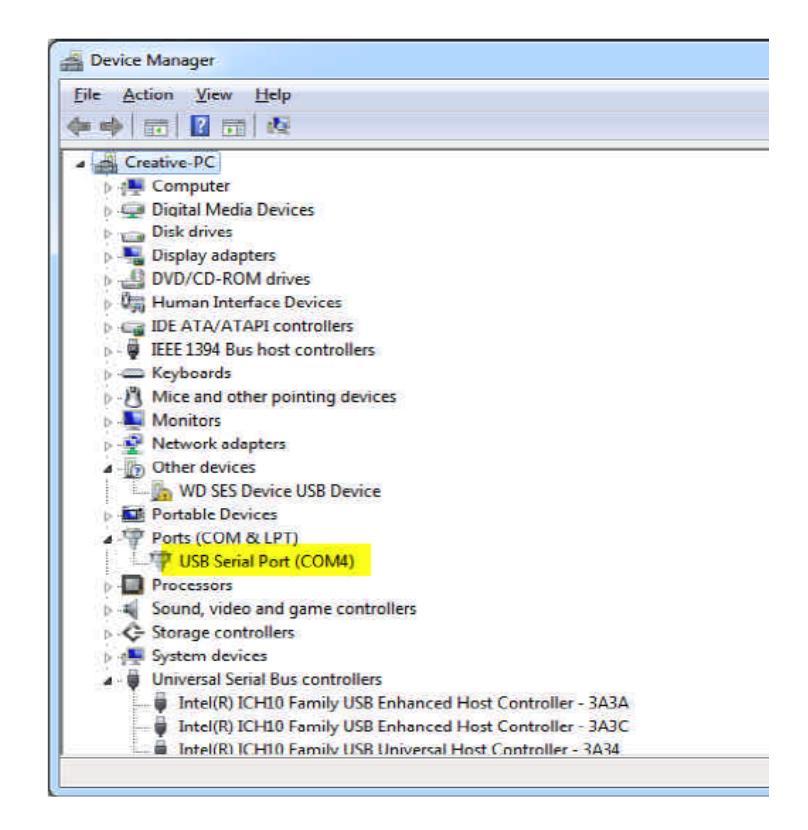
Does DM then show this following entry [yellow highlight].

If it does then that proves that your eLink is being detected and the eLink driver has been loaded into Windows correctly. In which case ignore the next section below and move on to the '<u>What to do in</u> <u>RailMaster</u>' section of this reply.

If it does not show the highlighted entry [note that the COM4 number may be another number such as for example COM3, COM5, COM6 etc], then the driver has not been loaded yet.

Once you get to the stage where Device Manager is displaying 'USB Serial Port (COMx)" where x is a number. Then take a note of the COMx number and move onto the next step below.
